Independent Investigation Report of the November 2005 Drum Fire at the Idaho National Laboratory Site

**Independent Investigation Report of the
November 2005 Drum Fire at the
Idaho National Laboratory Site**

**Idaho Cleanup Project
Radioactive Waste Management Complex
Idaho Falls, Idaho 83415**

RPT-190

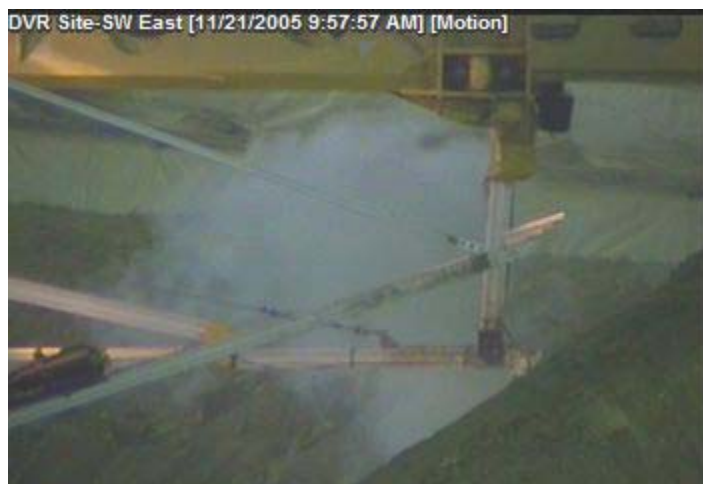
Based on review of the video evidence of the event, the team determined that it occurred at approximately 09:56 on November 21, 2005, while the camera operator had moved the camera to look at other operations in the ARP enclosure. There is a period of approximately 20 seconds where the excavator is not in view. When the camera is initially positioned to see the excavator again, there is no visual evidence (such as a plume or overhead material movement) that any event had occurred. After the fire is reported, the camera operator zoomed in on the excavation and white smoke was visible (Figure 6).

Figure 6. Smoke coming from fire after initial extinguishing effort.

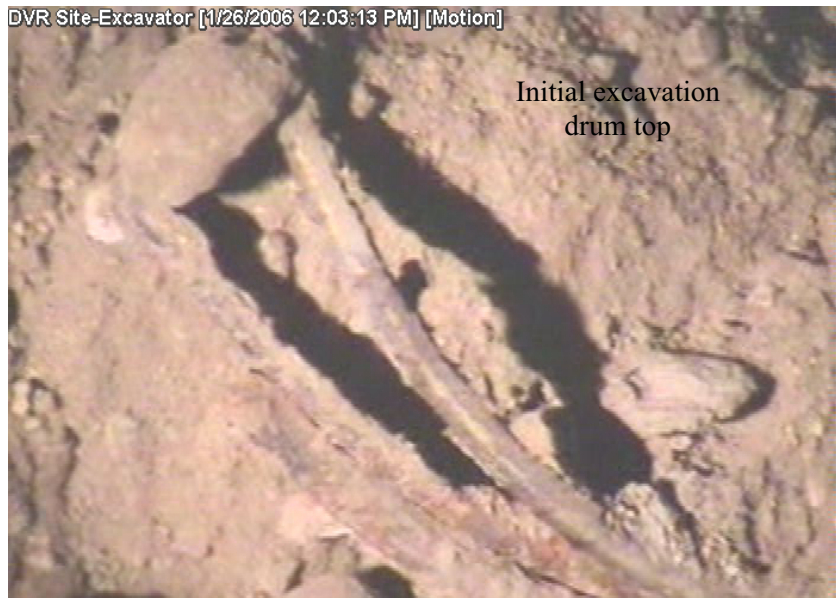
Almost immediately upon starting digging operations, what appeared to be the top of a drum and a drum ring were located (Figure 7). It appeared that the drum was only approximately 1 ft below the surface of the soil. Sample material was loaded into two trays and transferred into the DPS. A marker (overpack drum lid with a handle attached for ease of handling by the excavator) was placed on top of the “drum” and soil was placed over the marker.

Figure 7. Photo of initial excavation showing what was suspected as the corroded drum top and ring.

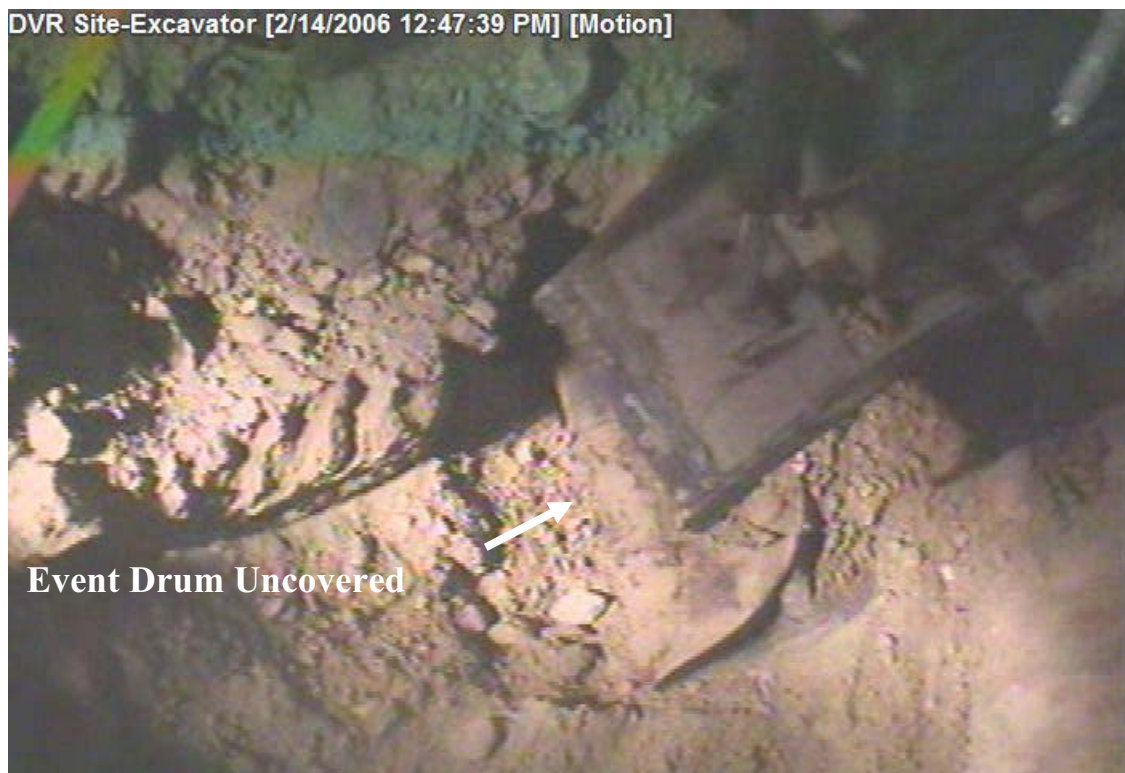
Excavation continued and the drum to be sampled was located a few feet away from and approximately 1-1/2 ft below the drum ring (Figure 8). The drum lid and drum ring were still in place on this drum. There was an opening at the top of the drum and the one drum side was compressed (Figure 9). During movement of the drum, gray material appeared to fall out of the drum opening. Following inspection of the drum externals, the drum lid was removed and an inner 30-gal drum was observed. The lid and ring of this drum were still in place. The top of the drum had what appeared to be a hole possibly from a puncture in it and appeared charred and pitted (Figure 10).

Figure 8. Photo of excavation of drum continued, showing top lid and ring.

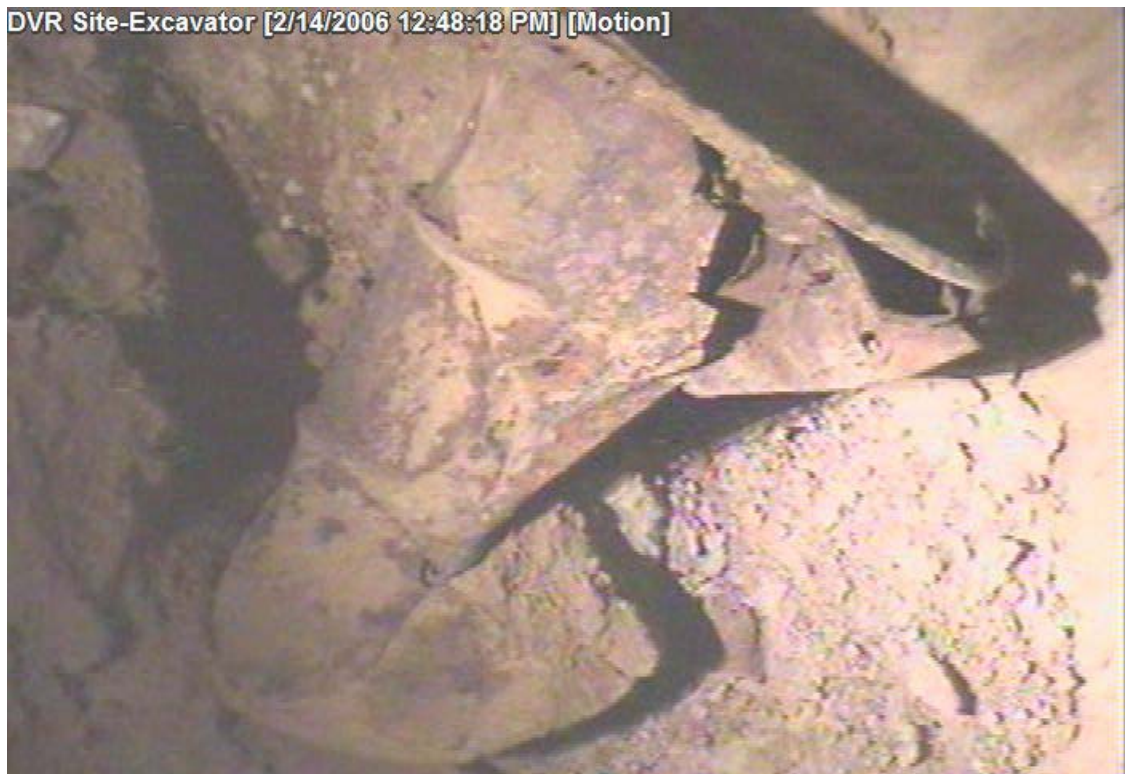
Figure 9. Photo of event drum exposed.

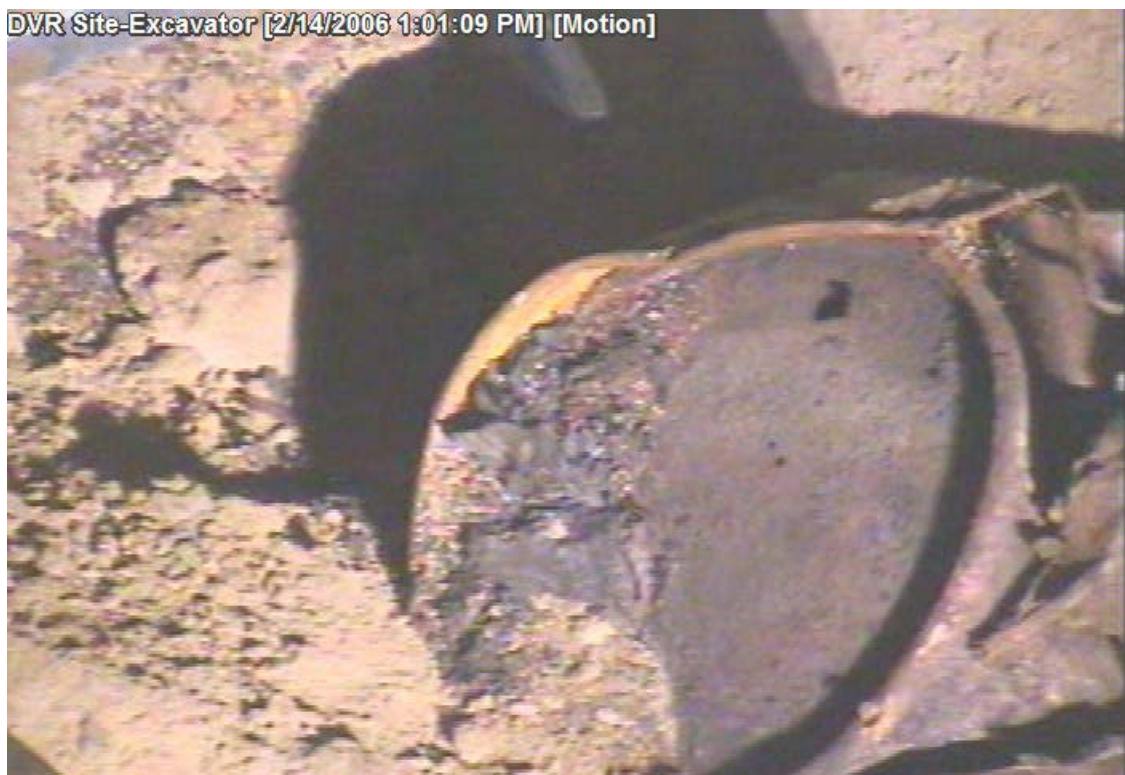
Figure 10. Photo of excavation of drum continued, showing top of the drum charred and pitted.

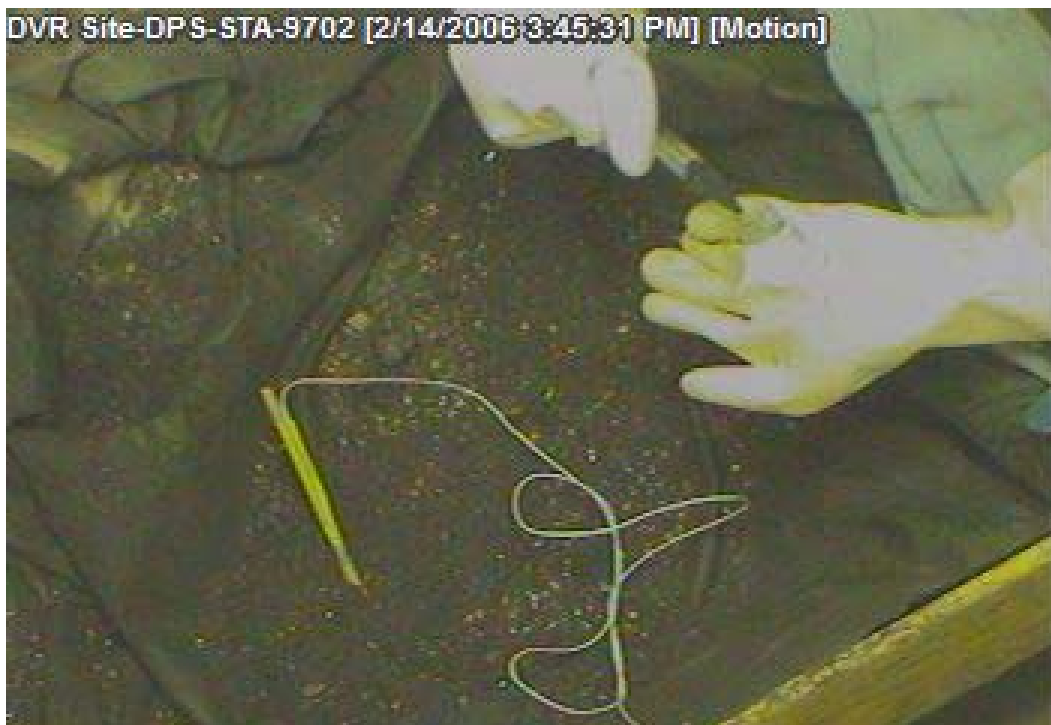
The inner drum was opened and found to contain a black granular/powdery material that was sampled and confirmed to be depleted uranium (roaster oxide).

The lid to the 30-gal drum was removed and material from this drum was placed in a tray for sampling. This material was black granular/powder in appearance (Figure 11) and created a significant dust cloud (Figure 12) when dumped into the tray. Some sparking was clearly visible in the bucket of the excavator when the excavator picked up the tray containing the 30-gal drum contents. A quickly dissipating set of sparks were seen coming from the area where the excavator jaw is joined to the bucket while the jaw was being closed (Figures 13, 14, and 15). After placing the trays at surface level, a small amount of the 30-gal drum contents was placed in a tray and raked through with the excavator. No sparking was noted.

Figure 11. Photo showing black granular/powder removed from 30-gal drum.

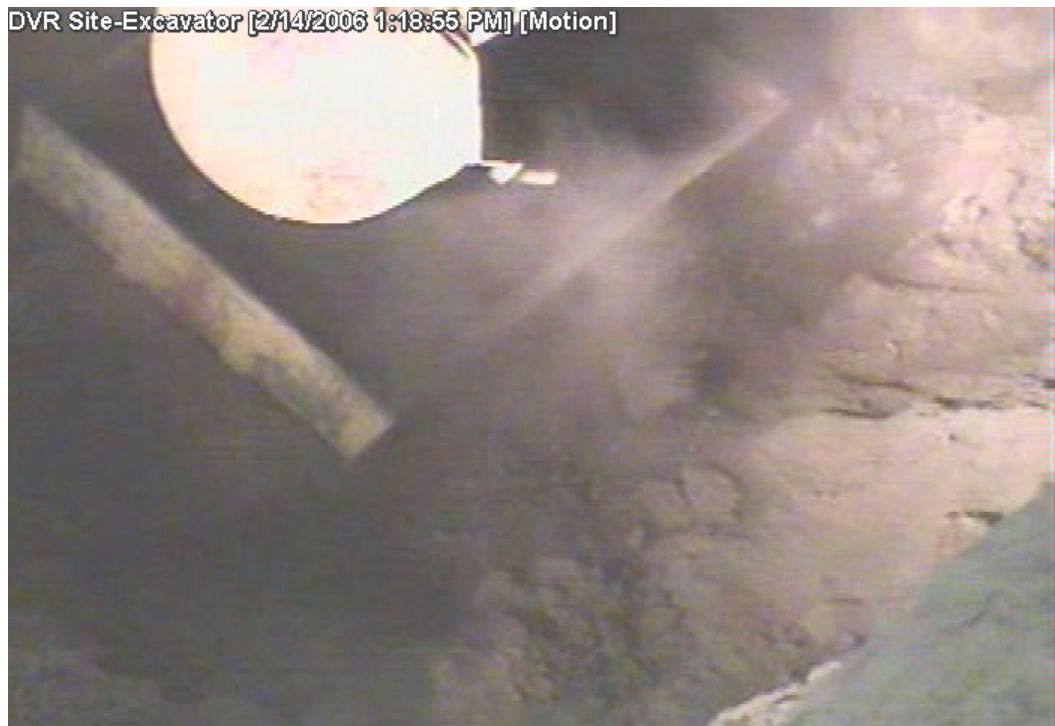
Figure 12. Photo showing dumping of black granules into tray, causing dust cloud.

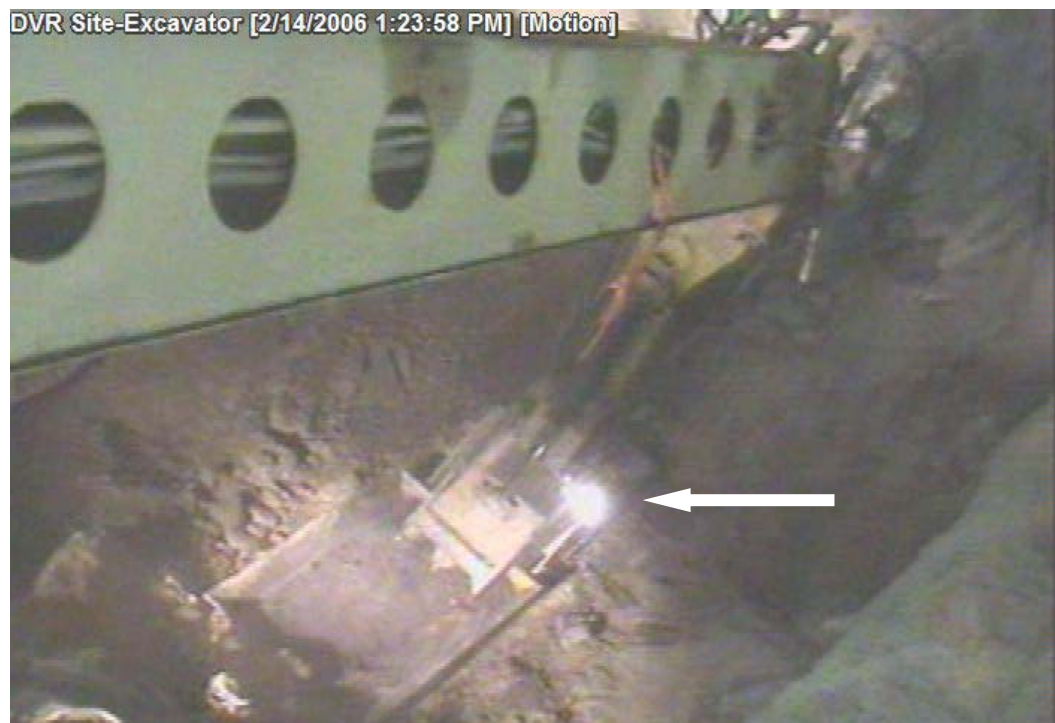
Figure 13. Photo showing sparks at jaw to bucket joint.

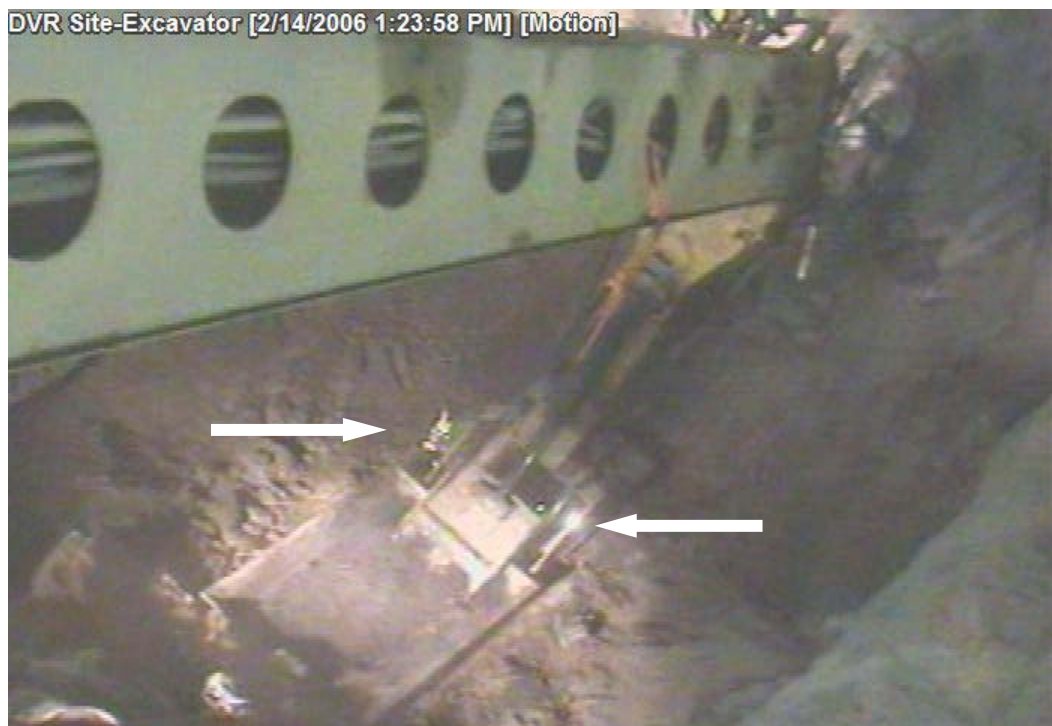
Figure 14. Photo showing sparks on both sides of the excavator bucket.

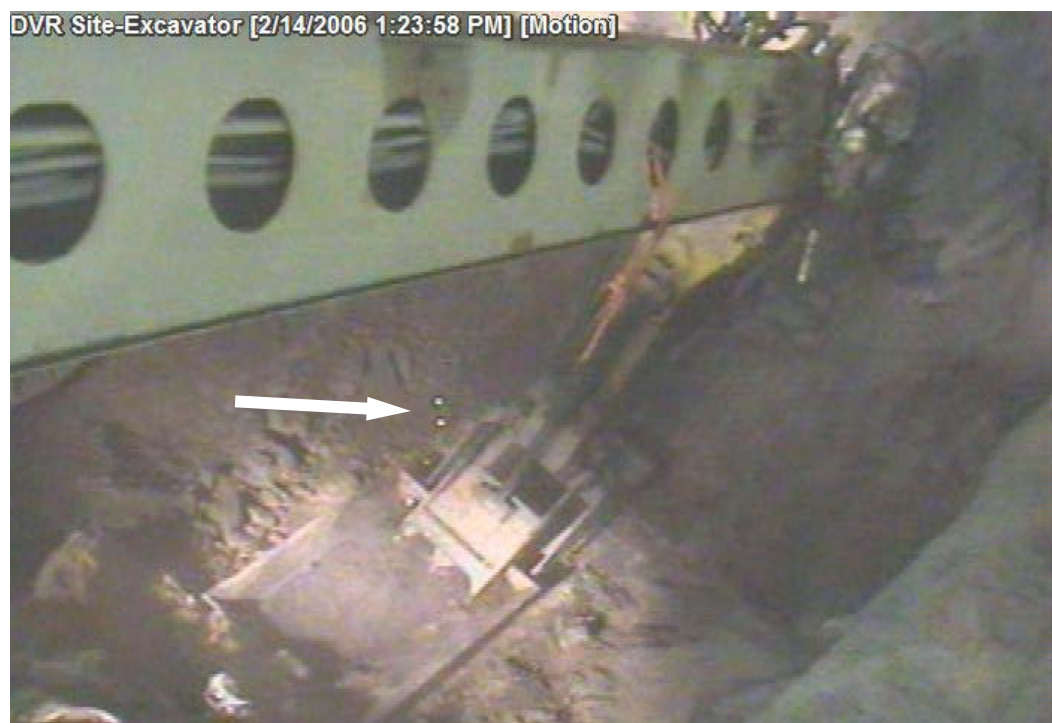
Figure 15. Photo showing sparks dissipating.

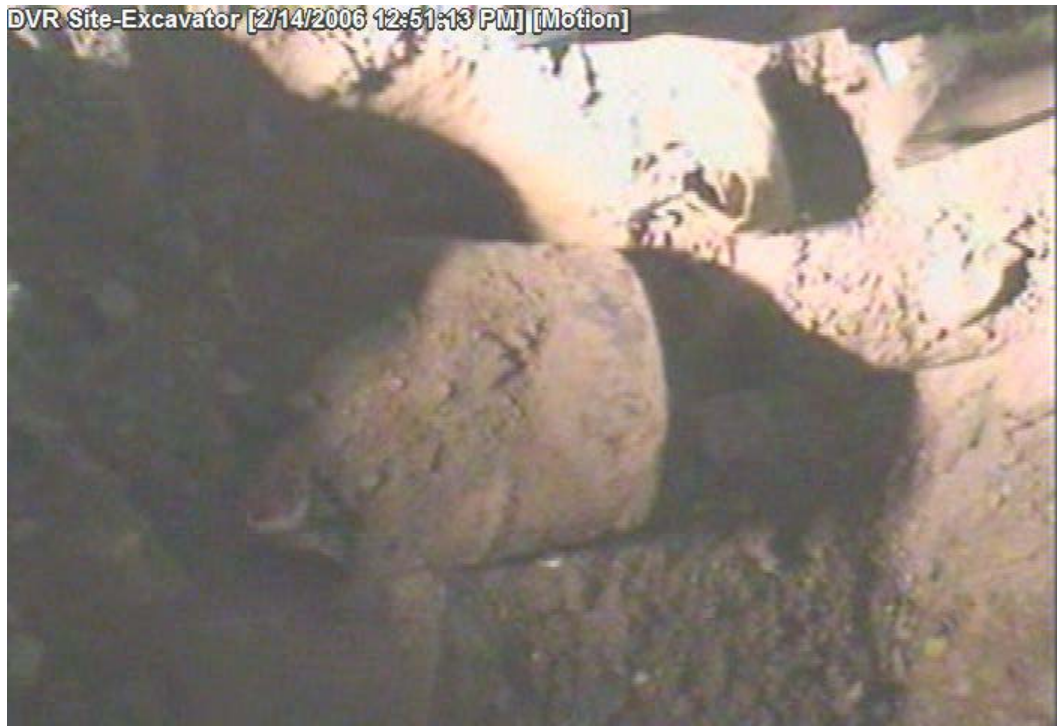
The drum the operator first vented and placed in the area was also located. It was immediately adjacent to the event drum (Figure 16). There was no visual evidence that the drum had been involved in a fire. The lid of this drum was found partially open, consistent with being squeezed by the excavator during venting. Plastic liner material was visible in the opening. This material displayed no evidence of melting or discoloration from a fire (Figure 17).

Figure 16. Photo showing drum next to event drum.

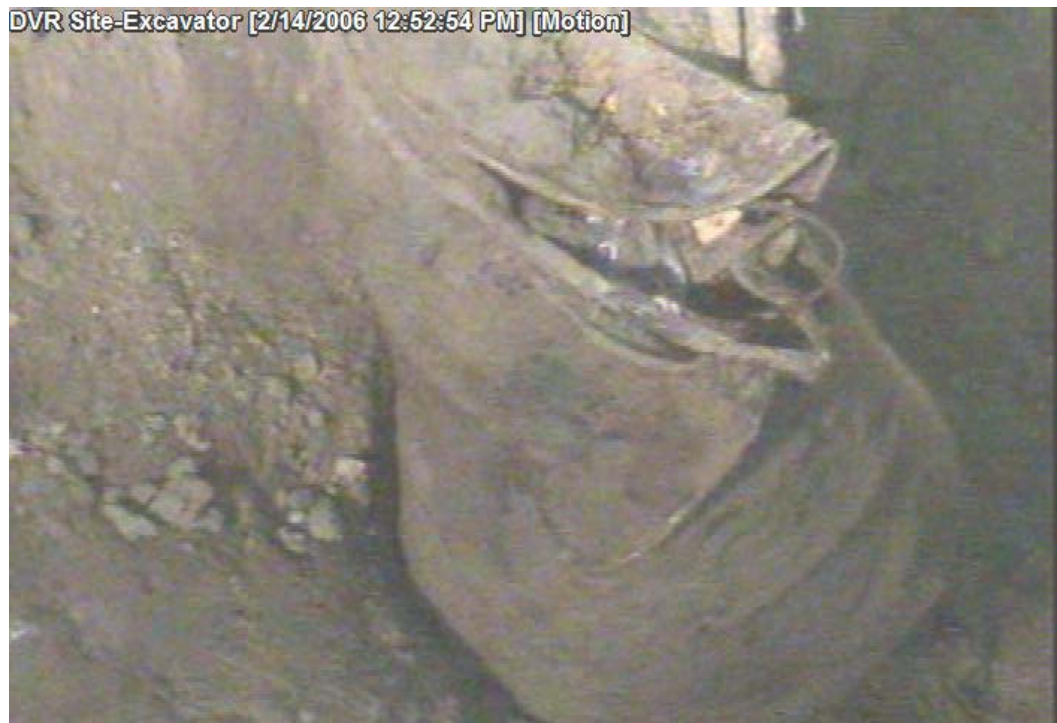
The drum that was next to the event drum had no visual evidence of being involved in the fire. The lid of this drum was found partially open, consistent with being squeezed by the excavator during venting. Plastic liner material was visible in the opening. This material displayed no evidence of melting or discoloration from a fire.

Figure 17. Photo showing drum next to event drum with no indication of fire.

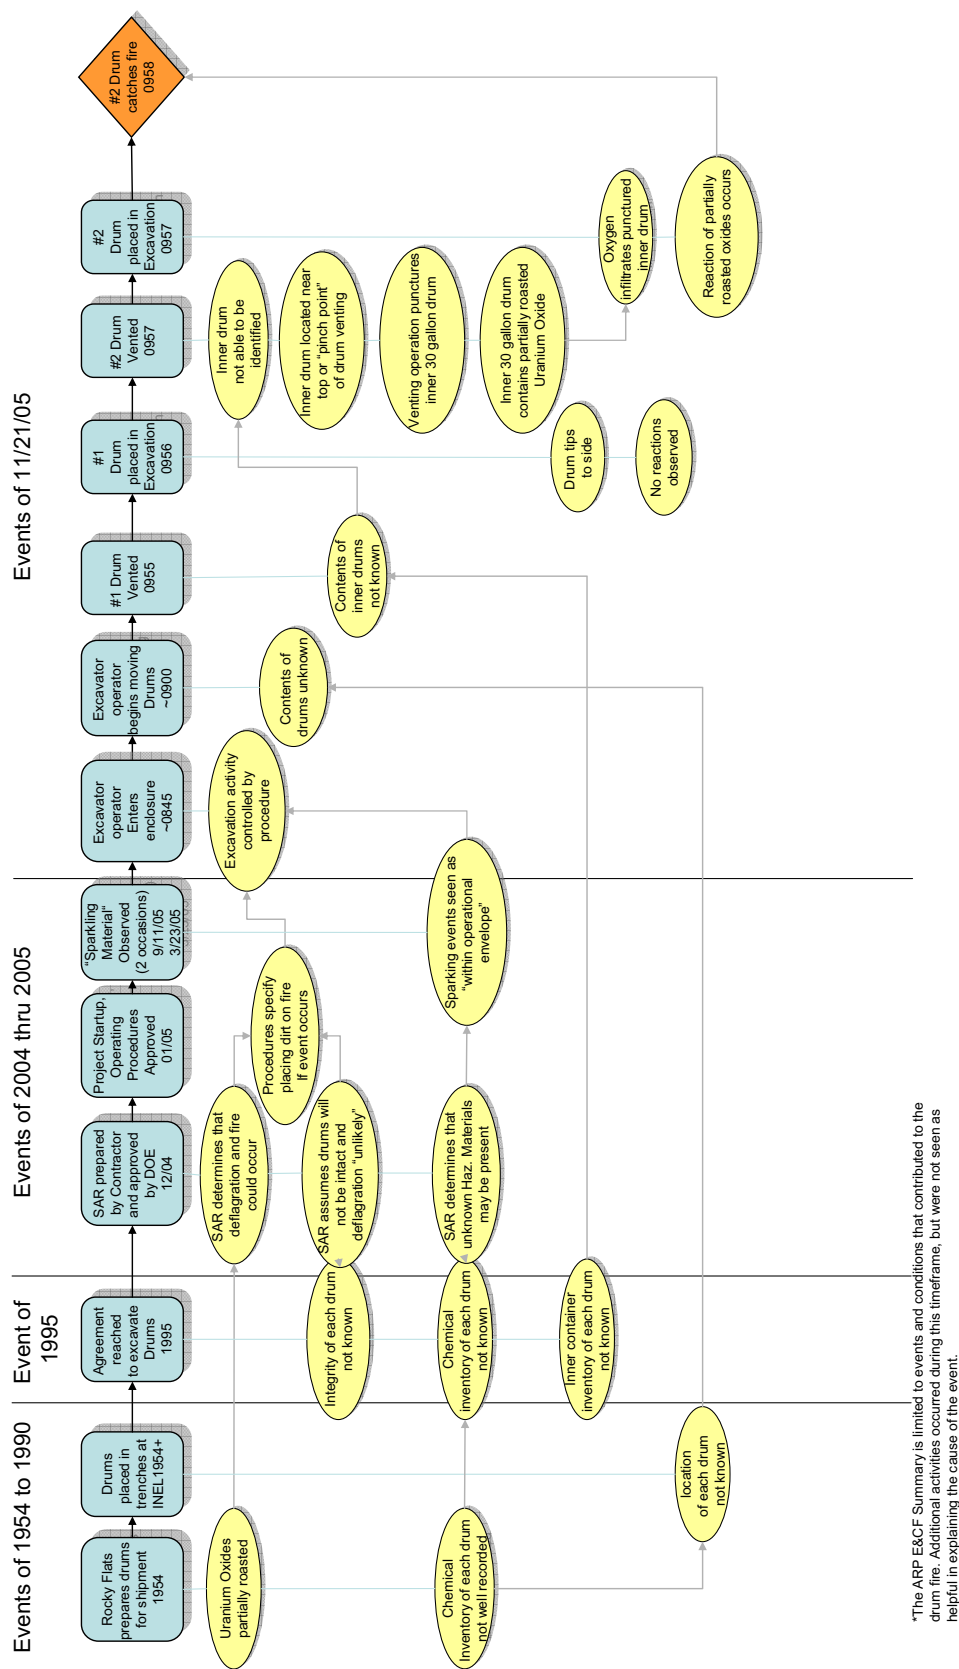
Figure 18. Events and conditions summary of the Accelerated Retrieval Project drum event.

Based on the type of waste being excavated, how the waste was originally placed in the pit, and the condition of the waste, the team did not find fault with the excavation method selected by the project. Additionally, even if all the recommendations of this report are fully and effectively implemented, a similar event is likely to occur. See Figure 18 (events and conditions summary diagram) and Table 4 (barrier analysis chart).

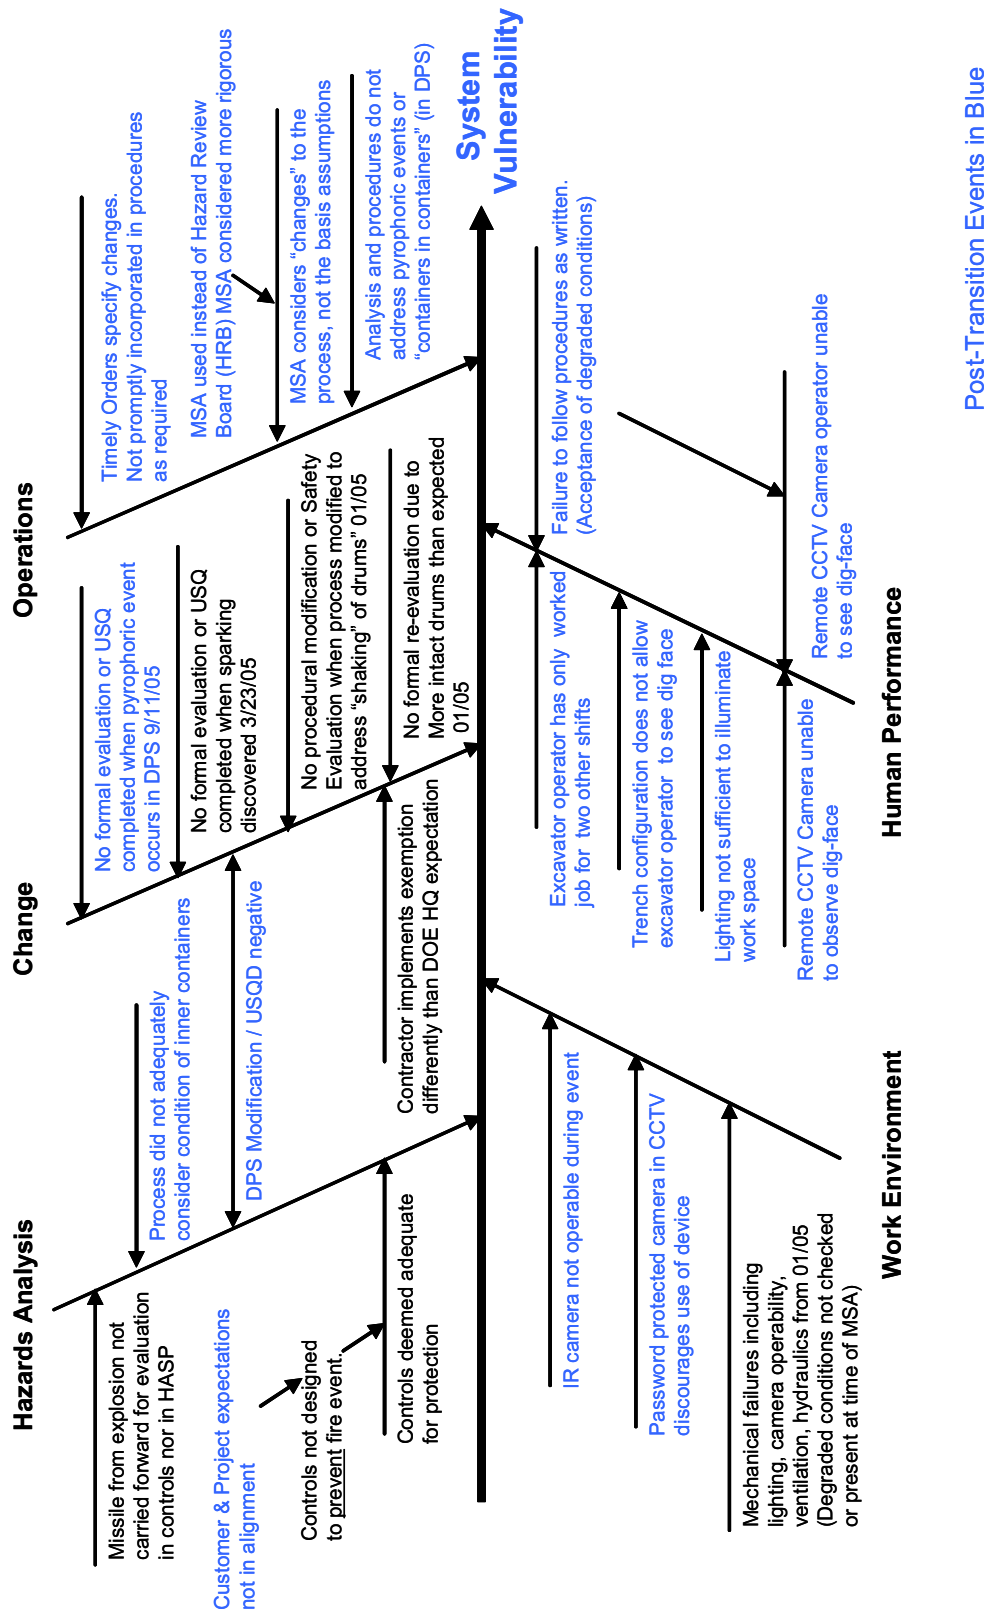
Figure 21. Accelerated Retrieval Project process weakness cause and effect diagram.

6.5.1.4 Potential Pyrophoric Indications in the DPS. On September 11, 2005, while performing hot work operations (drum opening with either a hole saw and/or sawzall) on a “spider” type container in the DPS, there was sparking between the saw and the container. After review of the tape by the team members, the team concluded that this was very likely an indication of pyrophoric material or other reactive metal event, most likely initiated while cutting through an inner container in the “spider.” There is some indication that silver may have been present and a silver compound could have reacted during the cutting process. The retrieval specialist operating the CCTV had recognized the sparking condition and initiated a review of the tape by project management, the fire protection engineer, and the industrial safety professional. They concluded that it was ordinary industrial metal-to-metal sparking. No formal evaluation was documented on this event. Figure 21 is a process weakness cause and effect diagram of the ARP.
